Evaluation and Retrofit of Steel Girder Shiplap Connections

B. Kozy

Michael Baker International, Baltimore, MD

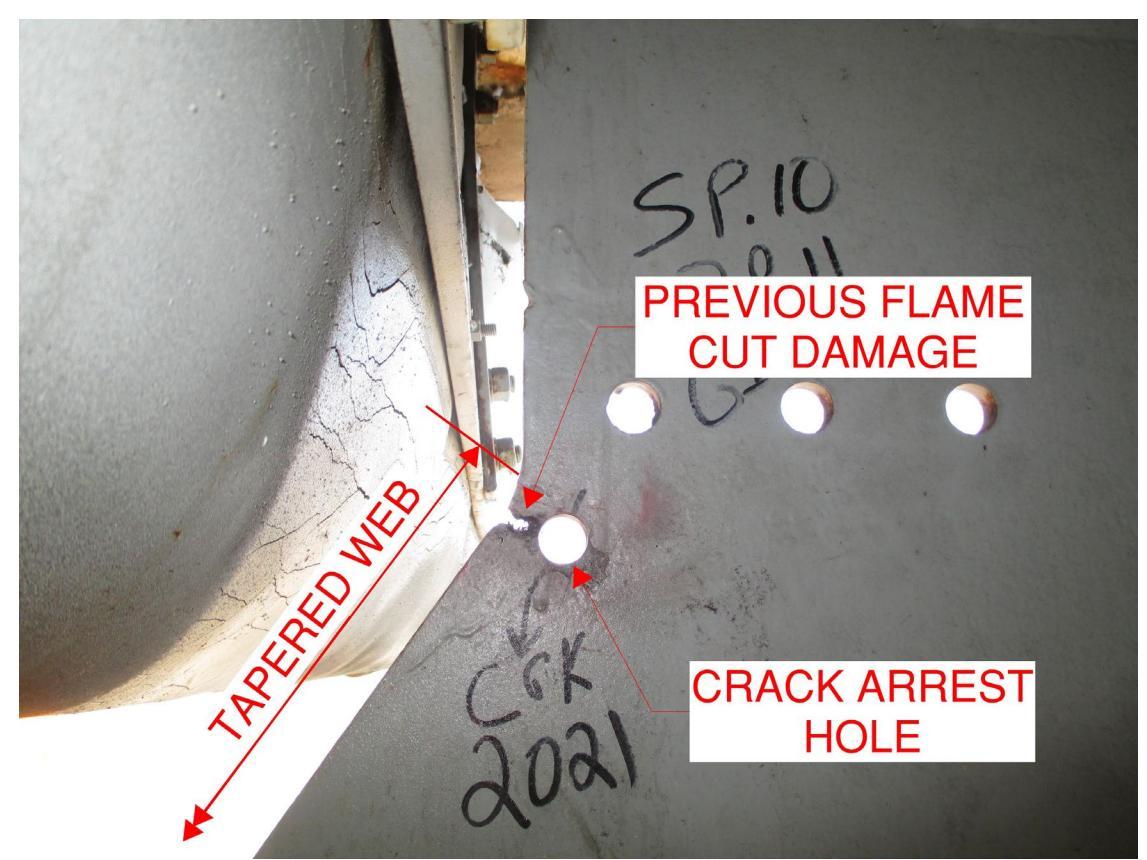
Figure 3. Photo of Crack Location with crack arrest hole drilled at tip of crack.

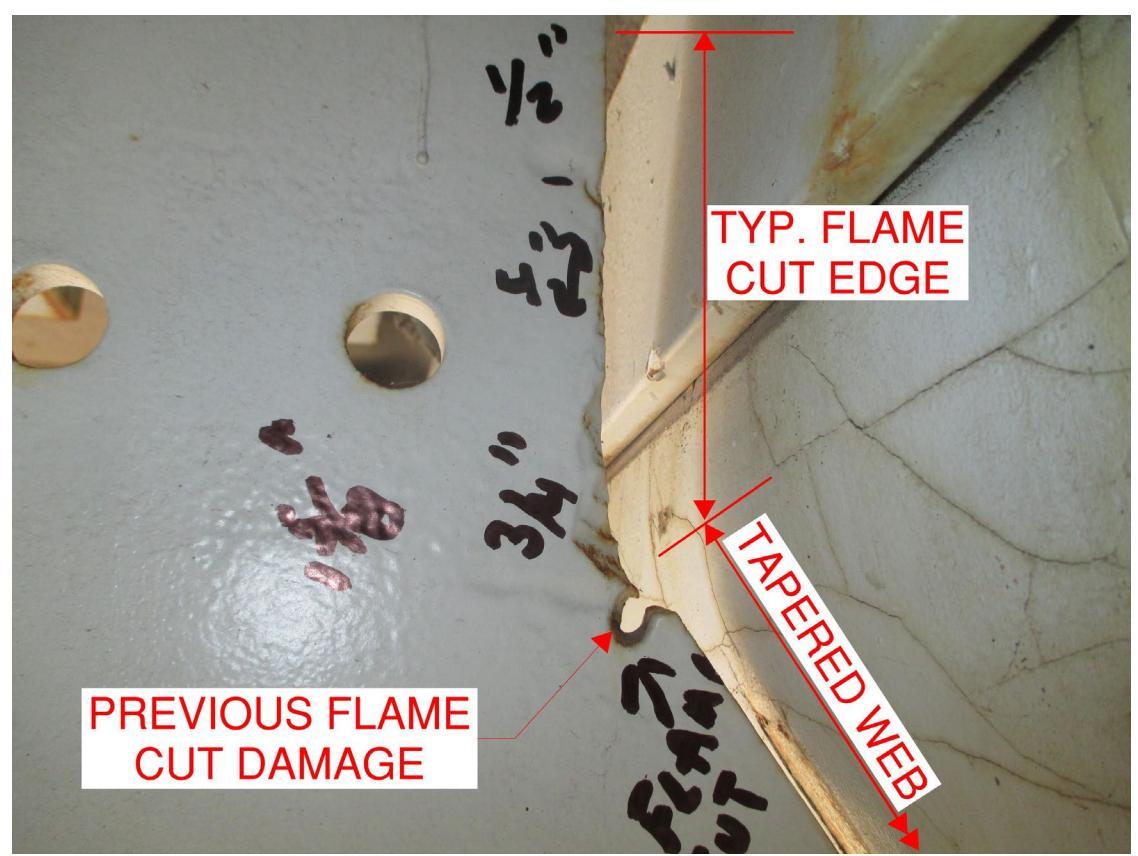
Figure 4. Typical flame-cut edge and flame-cut damage at end of tapered web.

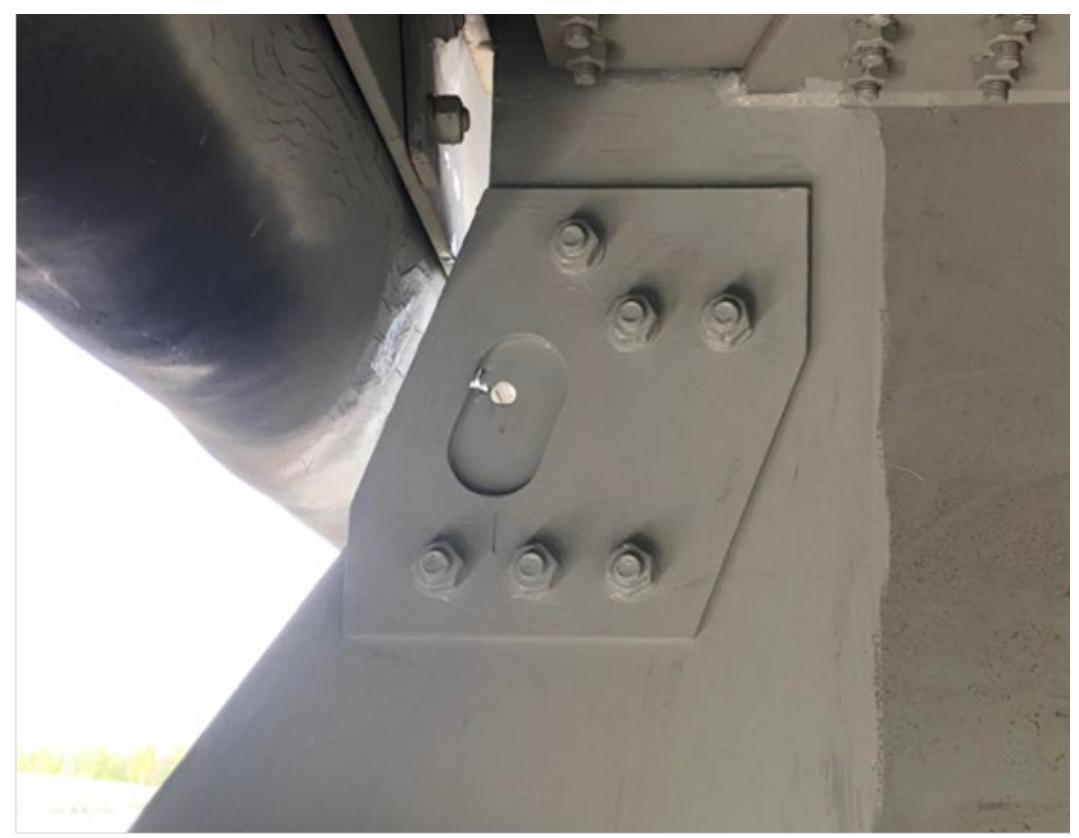
Figure 7. Final repair at arrest hole location (plate on opposite side not visible). (Courtesy of IDOT)

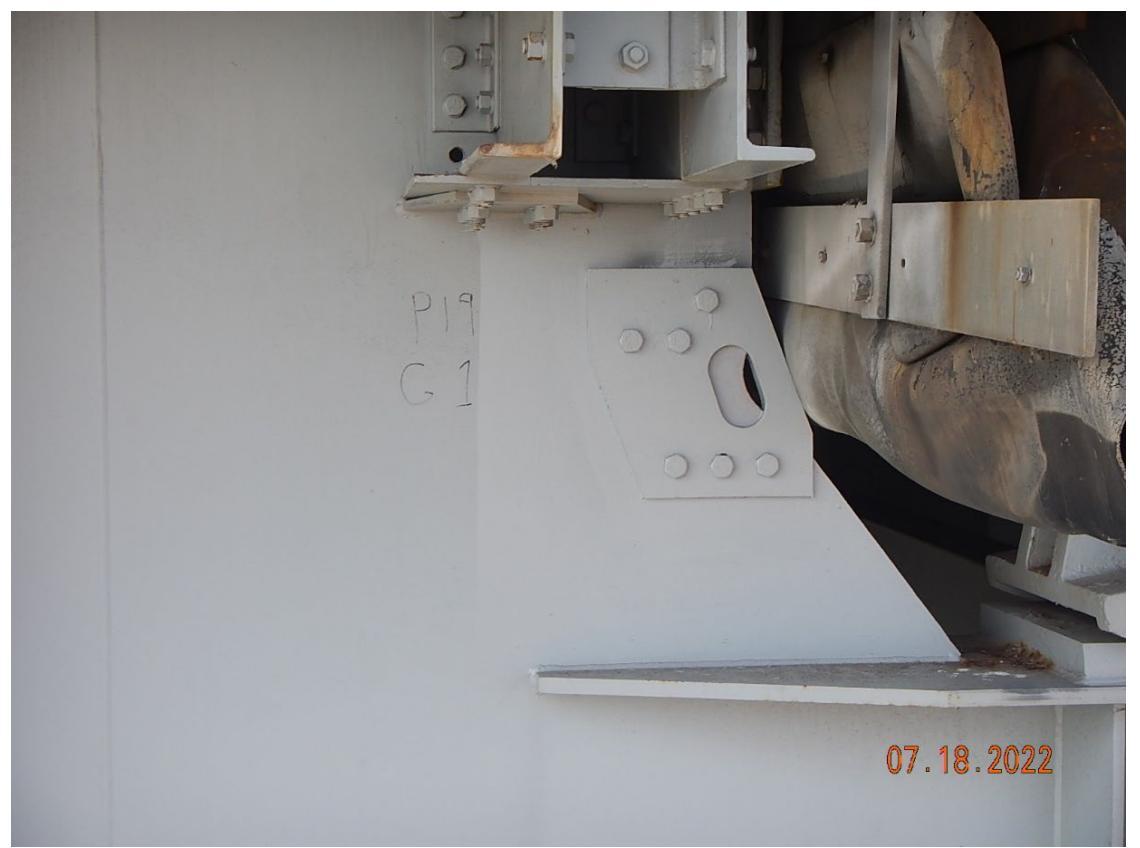
Figure 8. Final typical repair at web reprofiling (plate on opposite side not visible). (Courtesy of IDOT)

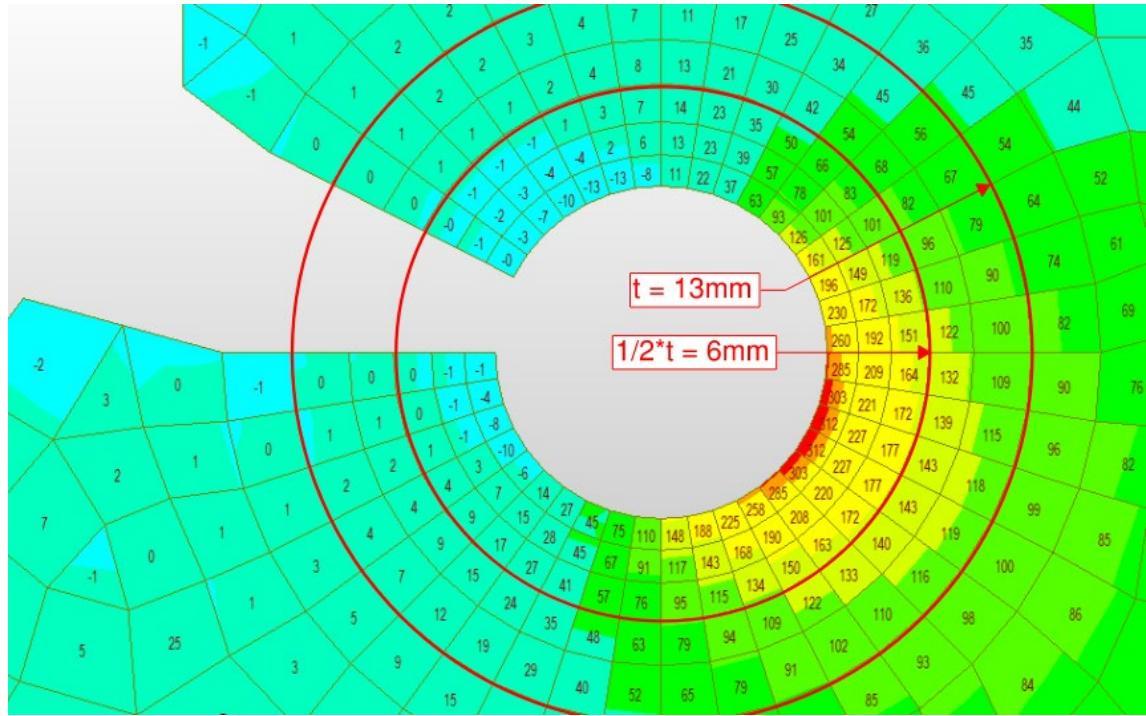
Figure 9. Fatigue stress gradient and offset limits at location with crack and arrest hole (MPa).

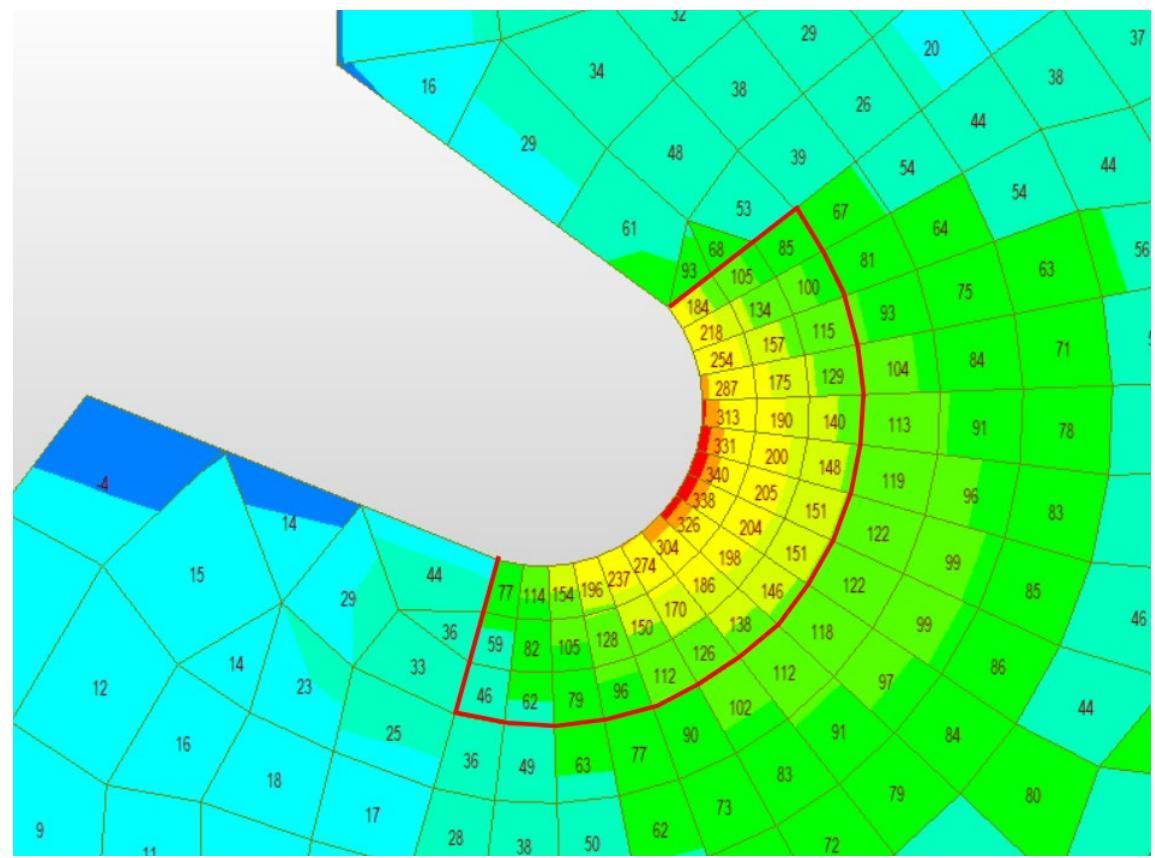
In this model, the web taper corner is modeled with a 19mm ($\frac{3}{4}$ ") deep gouge just below the corner to represent the flame cut damage that currently exists at some of these transition areas. A gouge radius of 6mm ($\frac{1}{4}$ ") is the minimum that can be accurately analyzed in MIDAS due to mesh size limitations. Any smaller radius will not be able to effectively define the stress concentrations with the appropriate amount of edge elements. A geometry including the crack cannot be modeled because FEA will require an assumed radius for crack tip for accurate results, and the minimum allowable radius is already used in the gouge geometry. The gouge is modeled with a 9-degree angle between adjacent elements. Figure 11 shows the gouge geometry maximum element stresses for the fatigue II stress range due to the LRFD fatigue truck in the linear-elastic model. The red boundary in Figure 11 shows the location 6mm ($\frac{1}{4}$ ") from the edge. The red boundary in Figure 12 shows the location 6mm ($\frac{1}{4}$ ") from the edge. This corresponds to the stress in the fourth row of nodes, and the sixth row of nodes corresponds to the stress range 13mm ($\frac{1}{2}$ ") from the edge.

Figure 11. Gouge geometry, fatigue II maximum element local tangential stress range (MPa).

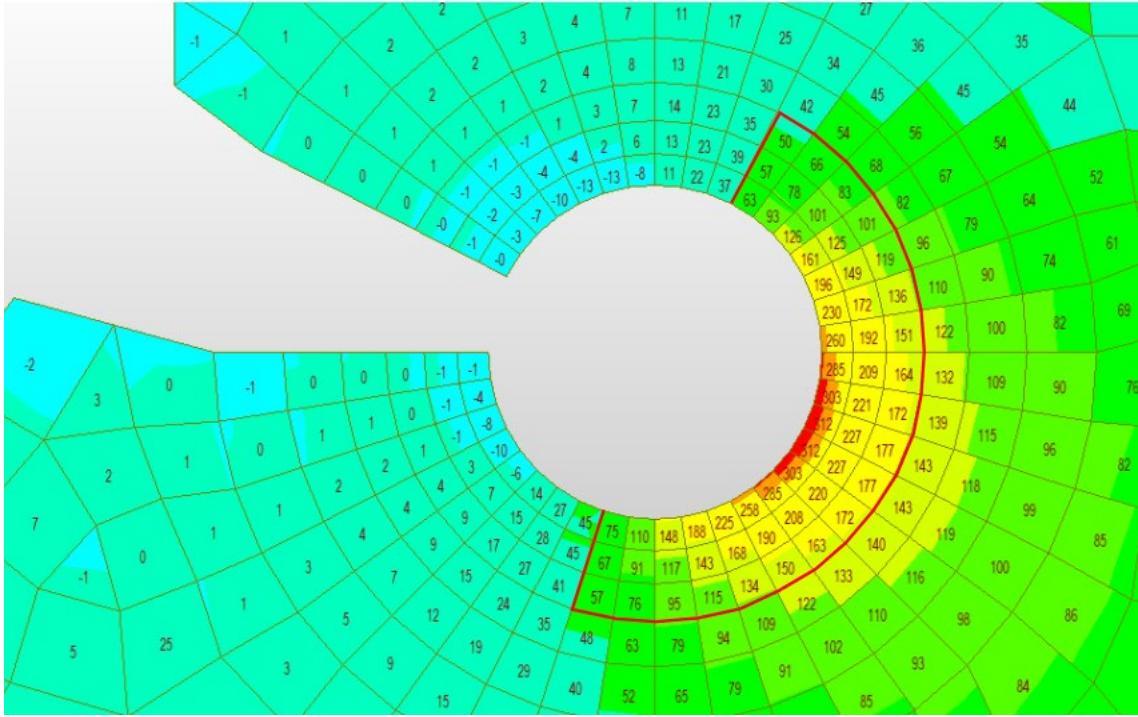
The web taper corner is modeled with a gouge, crack at the tip of gouge, and 21mm(13/16") arrest hole centered approximately at the tip of crack. This model represents the geometry at the location with the web crack at the time of the MBI inspection. Larger arrest holes sized 51mm(2") and 102mm(4") (maintaining approximately the same depth of cut into the web at the edge) were also modeled to demonstrate how the larger radius holes affect the stress distribution around the arrest hole. All the arrest holes in these models were able to be meshed with a minimum of 40 elements (9 degrees between adjacent elements) around the hole to ensure the accuracy of stress concentrations. Figure 12 shows the 21mm(13/16") arrest hole geometry maximum element stresses for the fatigue II stress range due to the LRFD fatigue truck in the linear-elastic model. The red boundary in Figure 12 shows the location $6\text{mm}(\frac{1}{4"})$ from the edge. This corresponds to the stress in the fourth row of nodes, and the sixth row of nodes corresponds to the stress range 13mm (½") from the edge.

Figure 12. 21mm (13/16") Arrest hole geometry, fatigue II maximum element local tangential stress range (MPa).

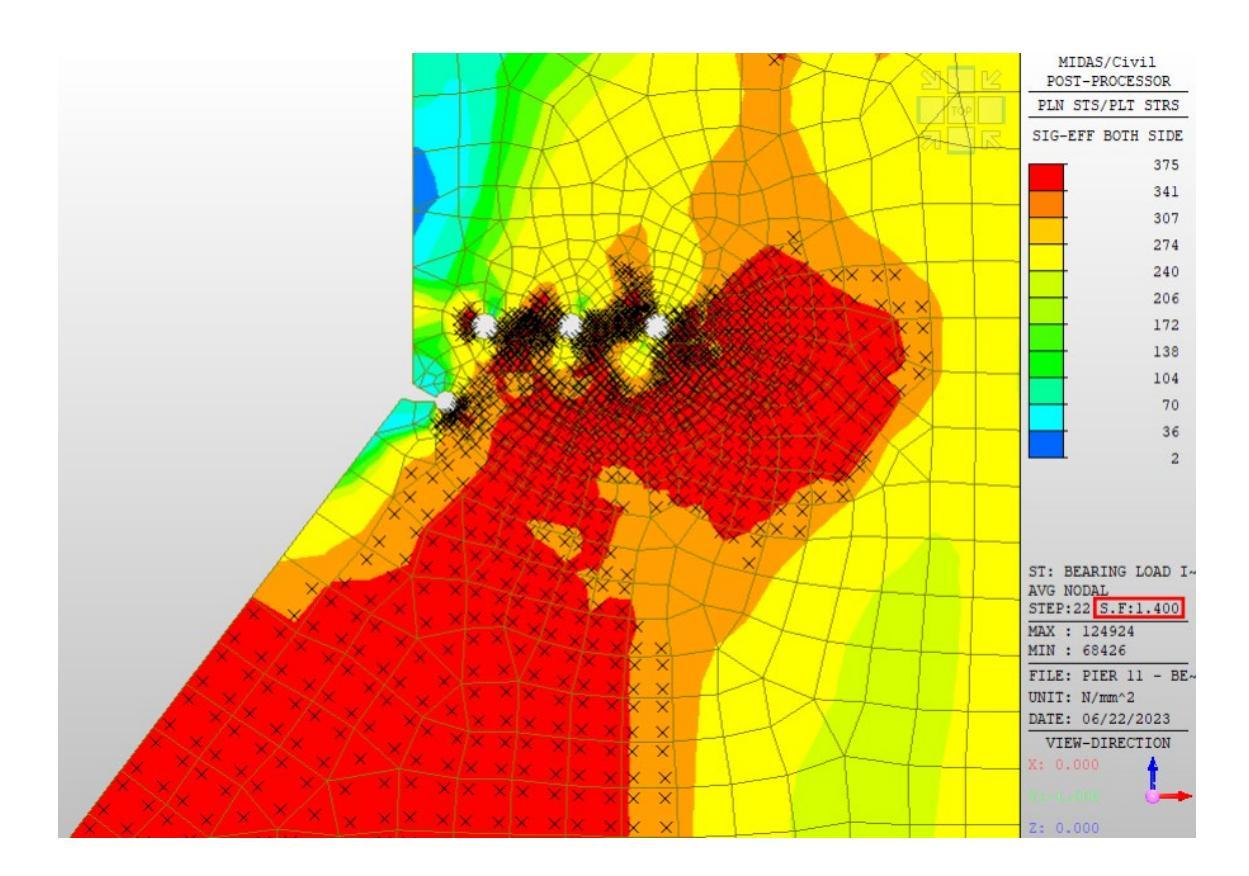
The FEA stress contours for the web plate at the ultimate loading indicate that the stress field is being interrupted by the arresting hole and bolt holes and localized stresses above yield do occur. However, plastic stress redistribution allows for further strength to be developed beyond point of first yield. The strap plates and bolts were included in the FEA models, but they were not designed like a typical splice plate would be because their main purpose is stiffening to reduce fatigue stress ranges in the web and not strengthening. These plates are not needed to increase the ultimate strength of the shiplap connection and therefore they are allowed to slip and yield, which is accounted for in the nonlinear FEA model. Also, these bolts and plates will only see vehicular live load and were designed to withstand Inventory level HS-20 loading. The rating for the shiplap connection remains higher than the controlling location of the bridge (from BrR) throughout the repair process, therefore no special restrictions are needed.

Figure 20. Stress state at ultimate from material non-linear analysis for arrest hole geometry (MPa).
