Evaluation and Retrofit of Steel Girder Shiplap Connections

B. Kozy

Michael Baker International, Baltimore, MD

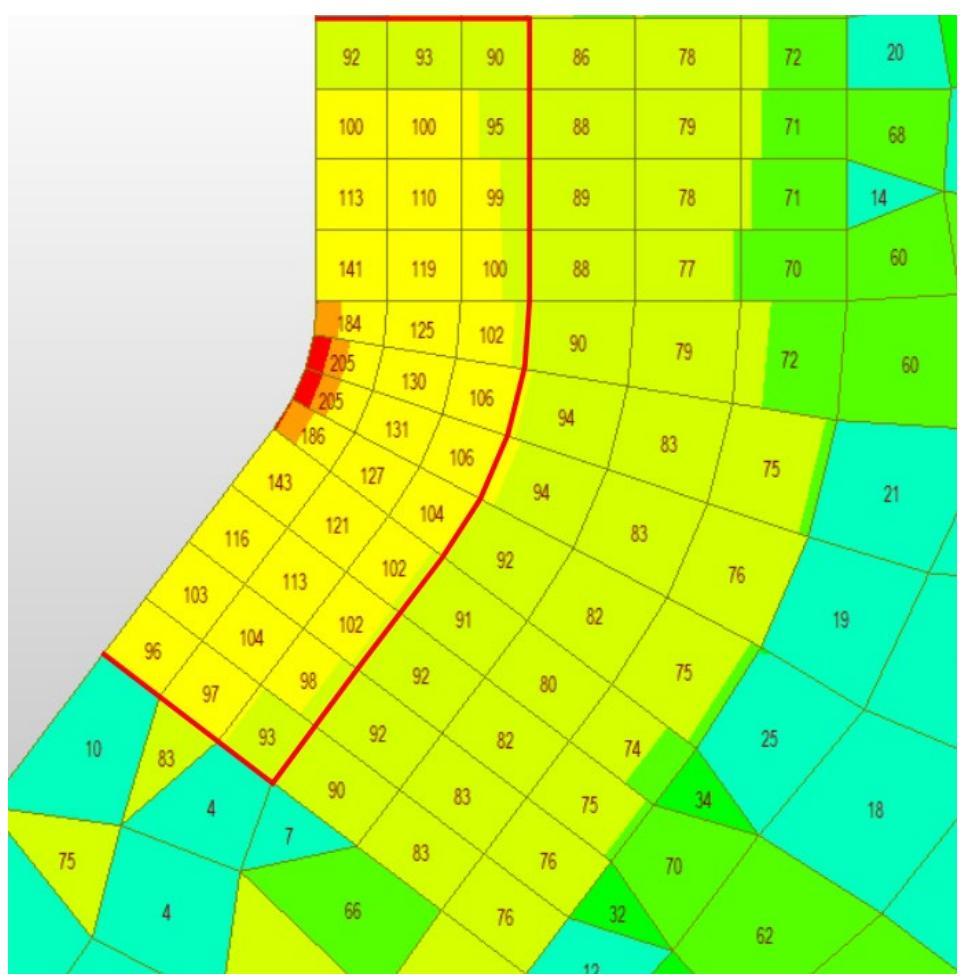
In this model, the web taper corner is modeled with a 6mm ($\frac{1}{4}$ ") radius which equates to four (4) elements with an edge distance about 1mm (1/32"). This radius is added as an attempt to characterize the stress field at this corner. Figure 10 shows the corner geometry and maximum element stresses for the fatigue II stress range due to the LRFD fatigue truck in the linear-elastic model. The red boundary in Figure 10 shows the offset location 6mm ($\frac{1}{4}$ ") from the edge. This corresponds to the stress in the fourth row of nodes, and the sixth row of nodes corresponds to the stress range 13mm ($\frac{1}{2}$ ") from the edge.

Figure 10. As-designed geometry, fatigue II maximum element local tangential stress Range (MPa).

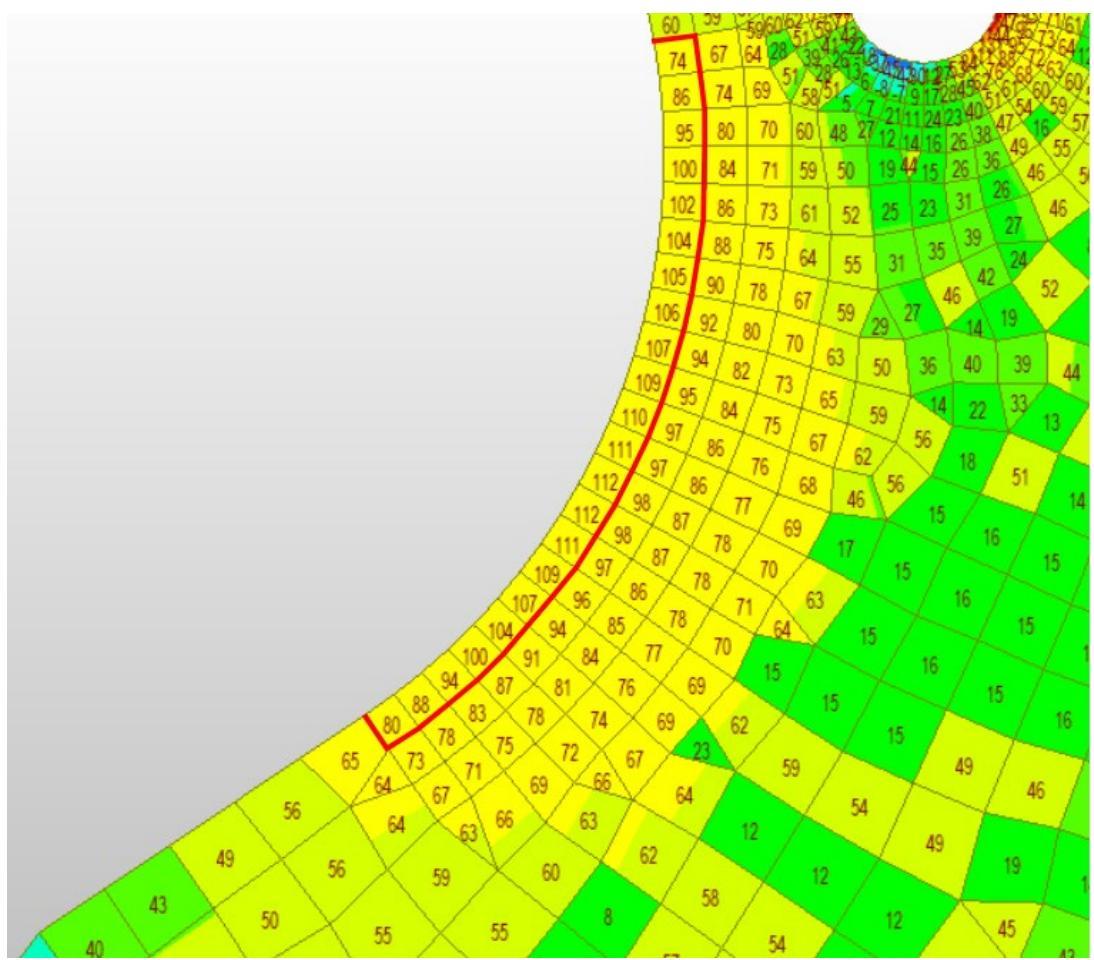
In this model the web taper corner is modeled with the entire corner removed and replaced with a smooth 102mm (4") radius transition. At the tangent ends of the radius an approximate 3-to-1 taper is used back to the edge of the web. This model represents an ideal repair at the location with the web crack. The radius is modeled with a 3-degree angle between adjacent elements increments. Figure 13 shows the 102mm (4") radius with taper geometry and maximum element stresses for the fatigue II stress range due to the LRFD fatigue truck in the linear-elastic model. Due to the amount of material removed in this repair detail, the maximum element edge stress shifts from the new radius edge to the edge of the nearest bolt hole. Although the edge stress is higher, the stress dissipates away from the bolt hole faster, and the 102mm (4") radius at 6mm (1/4") from the edge still controls the stress range. The red boundary in Figure 13 and Figure 14 shows the location 6mm (1/4") from the edge for the radius and bolt hole, respectively. This corresponds to the stress in the second and third row of nodes (for the radius and bolt hole, respectively) correspond to the stress range 13mm (1/2") from the edge.

Figure 13. 102mm (4") radius geometry, fatigue II max element local tangential stress range (MPa).

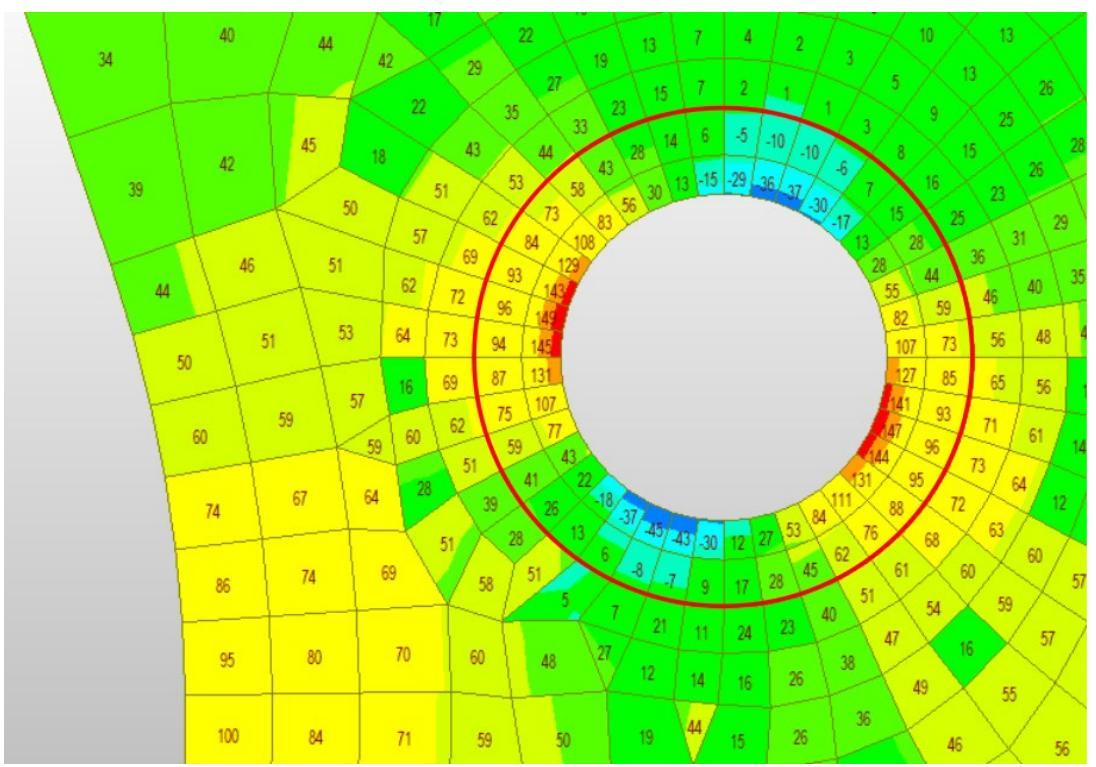
Figure 14. 102mm (4") radius (at bolt hole), fatigue II max element local tangential stress range (MPa).

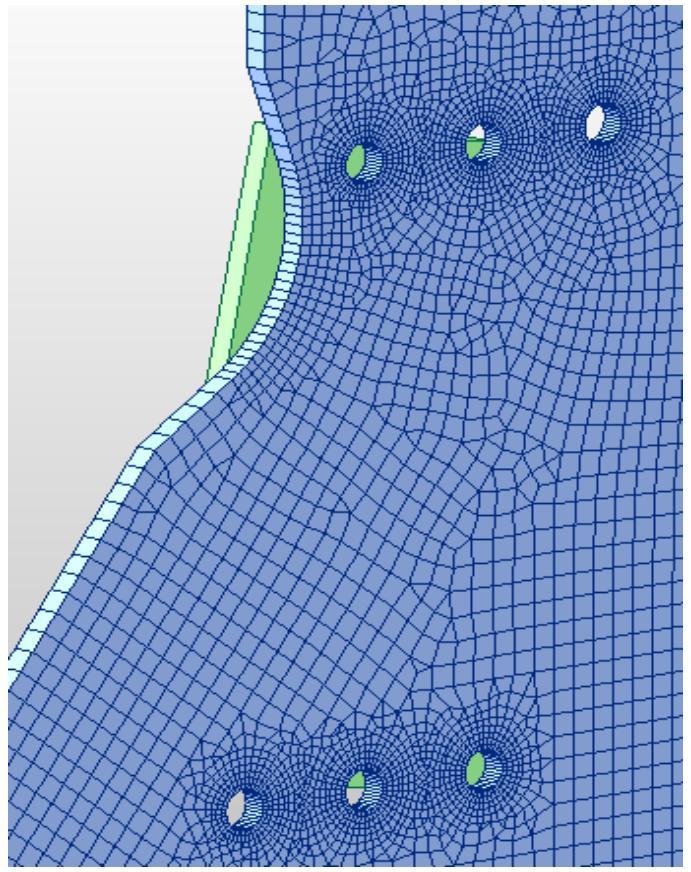
Figure 15. Typical 102mm (4") radius reprofiled model with longer repair straps (front plate not shown).

Because an additional reduction in fatigue stress range was still required to achieve the minimum required fatigue life in these details, the addition of steel "strap" plates on one or both sides of the web was investigated. For this investigation, it was assumed strap plates would be added to the 102mm (4") radius reprofiled web repairs and at the single crack arrest hole location. The strap plate would use two of the three existing trough support bolt holes and require three new holes drilled below the web taper area and one above the trough support holes. Nine different strap plate configurations were investigated for each detail, which included a plate only on one side of the web vs both sides of the web, $6mm(\frac{1}{4})$ vs $13mm(\frac{1}{2})$ vs 25mm(1) thick plates, and a longer strap, 350mm (14") between bolt holes vs a shorter strap, 200mm (8") between bolt holes. It was not possible to achieve infinite life with the single plate details because the single plate induced additional bending in the web increasing the stress on the outside of the web. Some single plate configurations did still increase the fatigue life of the repair. When strap plates were used on both sides of the web, the additional bending stress was eliminated, and the overall fatigue stress ranges were reduced as well. Many of the two plate configurations were able to achieve infinite life. See Figure 15 for an example of the reprofiled web with strap plates and Figure 16 for the crack arrest hole with strap plates. A summary of analyzed stress ranges and associated fatigue life is provided in Tables 2 through 4. In the tables Fatigue I stress ranges are multiplied by 1.75 and Fatigue II stress ranges are multiplied by 0.8. [1]

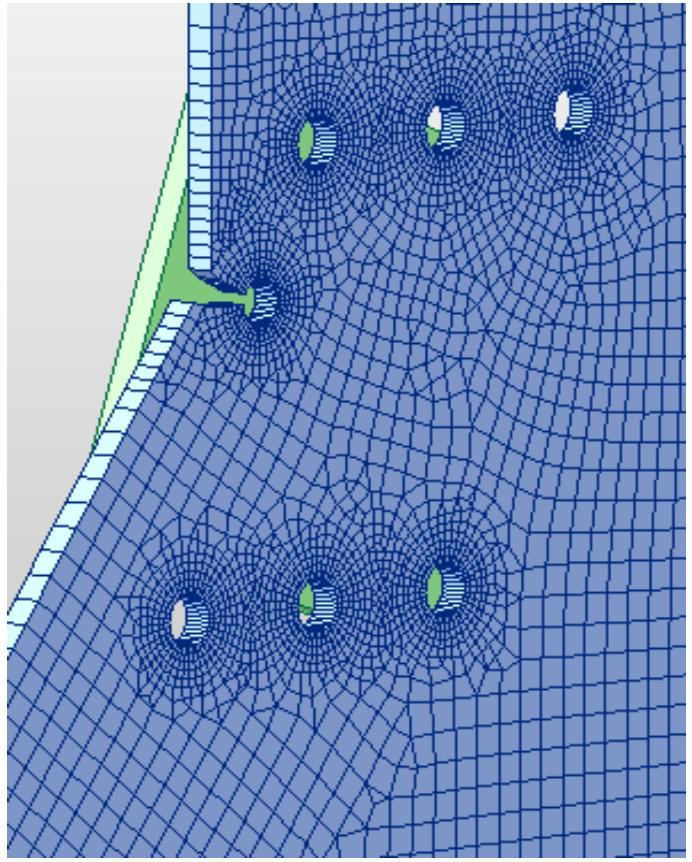
Figure 16. Crack with arrest hole model with shorter repair straps (front plate not shown).

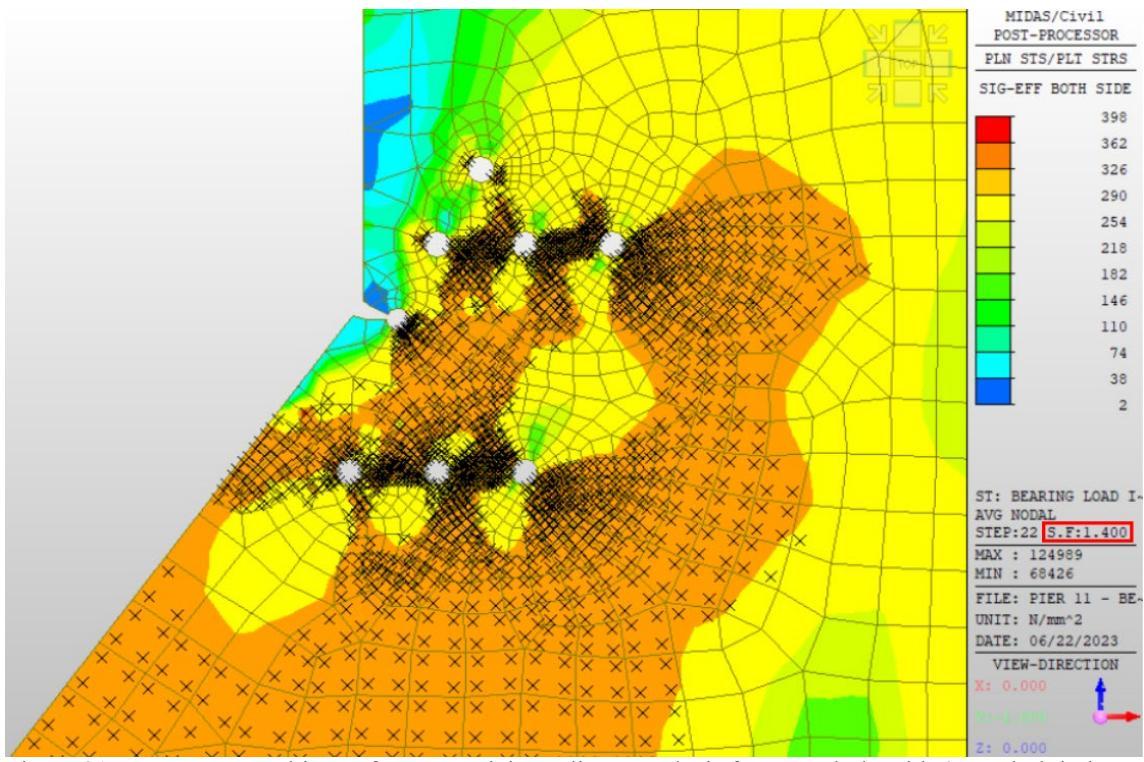
The stresses throughout the tapered web region for the model with the crack and arrest hole throughout the web modifications are shown in shown in Figures 20 through 22. The figures represent the stress state at the final converging step in the material non-linear analysis results and show how force distribution changes throughout the web but still reaches a similar ultimate capacity. Note that "x" in Figures 20 through 22 represent local web steel yielding and redistribution of forces.

Figure 21. Stress state at ultimate from material non-linear analysis for arrest hole with 4 new bolt holes (MPa).

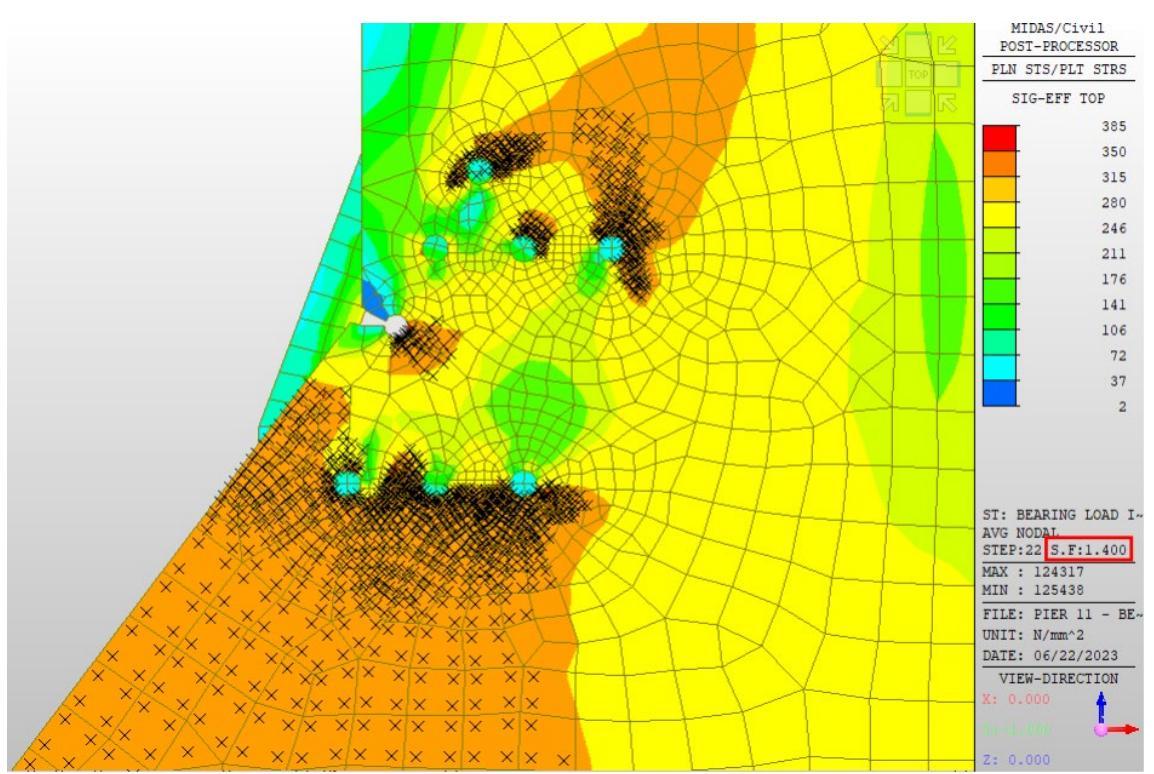
Figure 22. Stress state at ultimate from material non-linear analysis for arrest hole with 4 new bolt holes and repair plates (front plate not shown for clarity) (MPa).

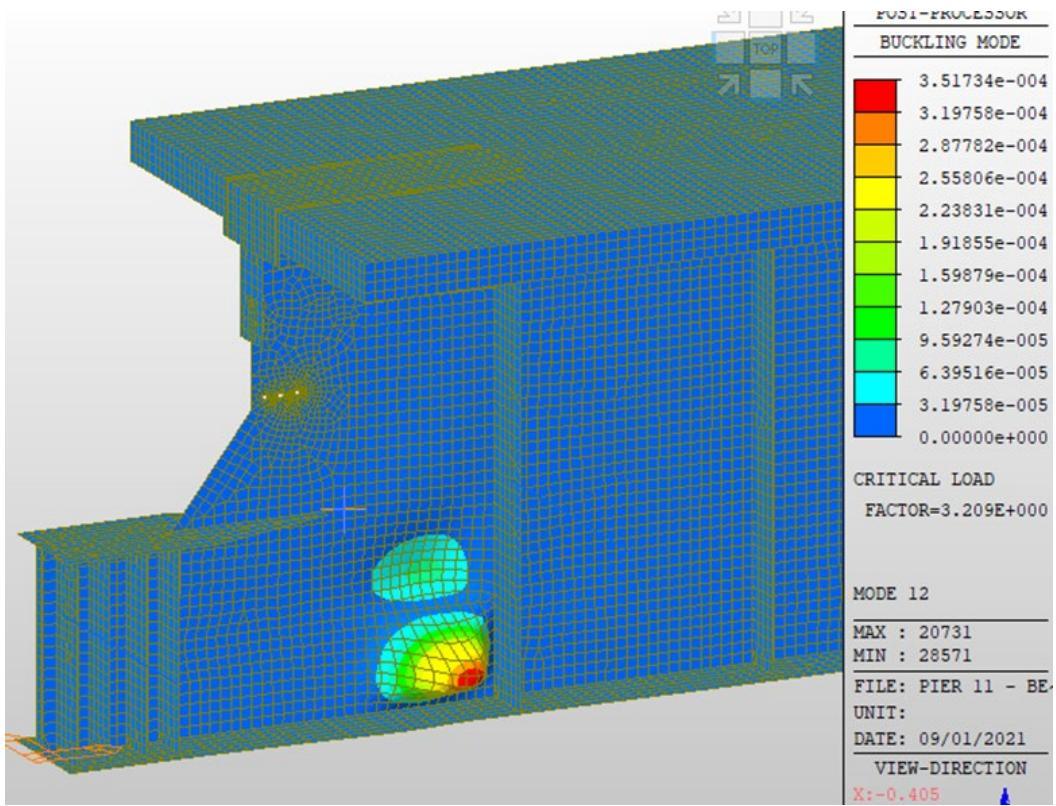
The critical load factor for this mode was determined to be 3.2, which means that buckling would be predicted at this value times the applied load. The model for this analysis was loaded with the factored LFD inventory load of 1713kN (385kips) obtained from the AASHTOWare BrR model. This mode represents a critical load of approximately 3.2*1713=5482kN (1232kips) where 1713kN (385kips) comes from the LFR Inventory HS20 loading. With such a high critical load (2.28 times the ultimate load from the nonlinear analysis), it was concluded that buckling would not create a meaningful reduction of the ultimate strength.

Figure 23. Lowest applicable cantilever girder end region buckling mode and critical load factor.

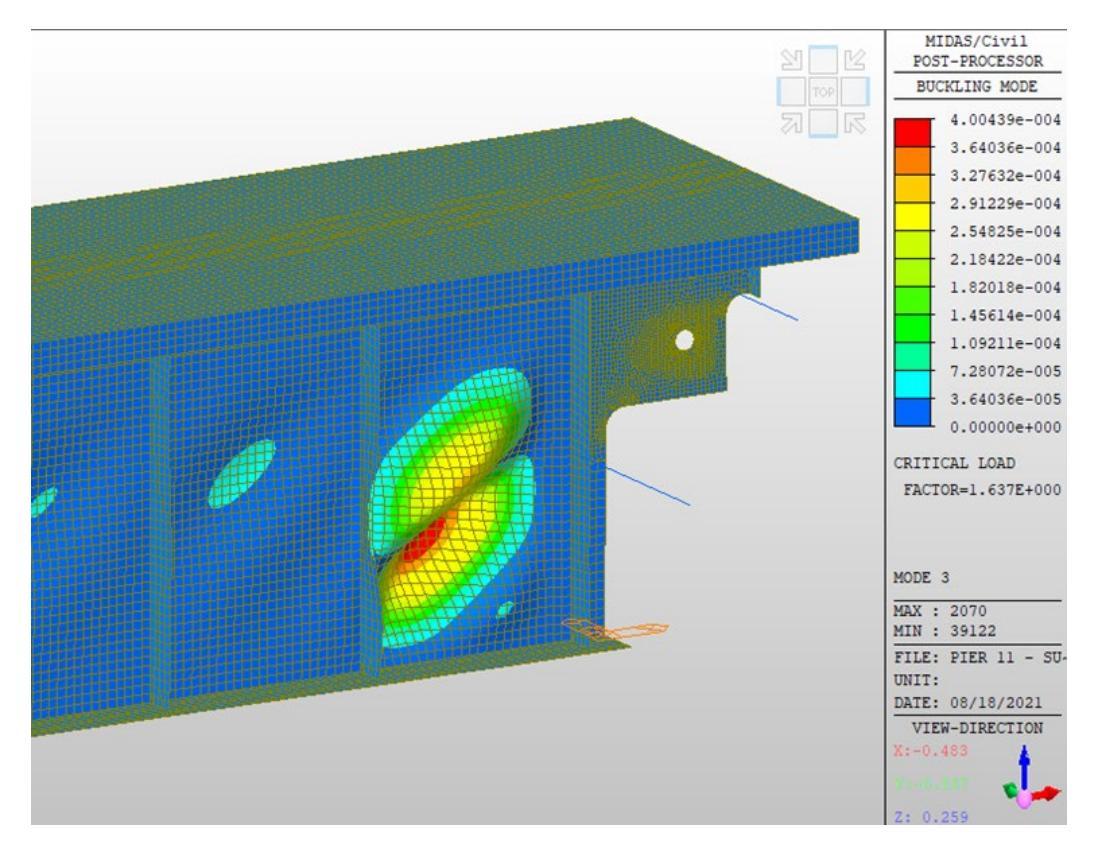
Buckling analysis was also performed on the suspended span girder end region. In this case, the lowest applicable critical load factor in the support web panel was found to be 1.6, which translates to a critical load of 1.6*1713=2741kN (616 kips) where 1713kN (385kips) represents the LFR Inventory HS20 loading. This mode corresponds to shear buckling of the web, which will be captured by the AASHTOWare BrR load rating code check. No further investigation was deemed necessary.

Figure 24. Lowest applicable suspended span girder end region buckling mode and critical load factor.
